# Case Examples of Visually Impaired People Falling Off from a Platform of Train Stations

University of Tsukuba MIZUNO Tomomi  
University of Tsukuba TOKUDA Katsumi

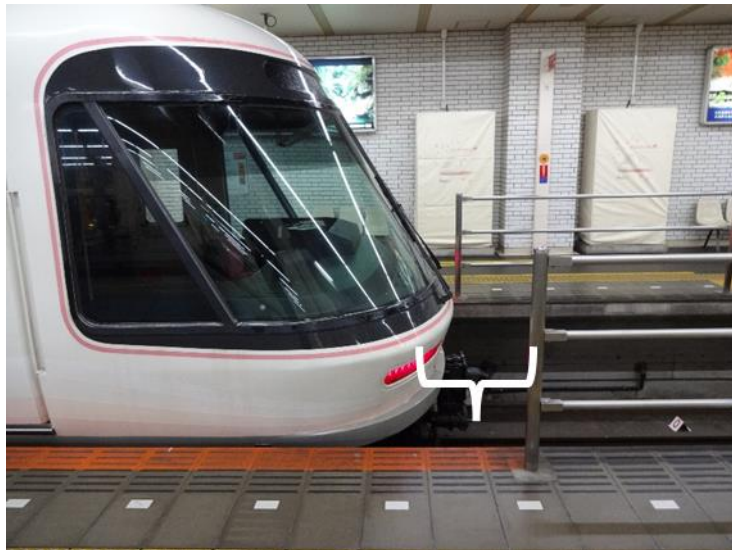
Photo 1. The clearance between the falling prevention fence and the front carriage of the train (Osaka-Abenobashi, Kintetsu Railway)

As for a person who “mistook the clearance between the fall prevention fence and the front carriage for open door” (15%) on a platform where fall prevention fences were installed, this person became panicked while trying to get on a train already arrived at the platform and mistook the clearance between

the falling prevention fence and the front carriage of the train for a door of the front carriage (Photo 1).

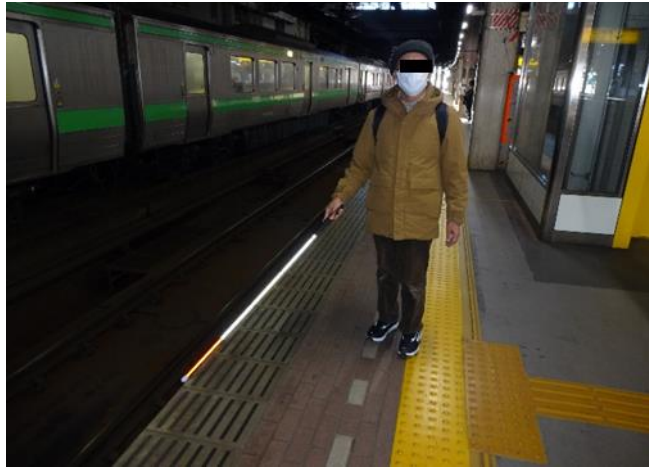
Photo 2. A visually impaired person walking while feeling the edge of the platform

For a question about how to walk in the direction of long side of the platform without platform doors, the answers included that “I walk inside the warning blocks (inner platform) while checking the tactile directional bars attached to the warning blocks with my white cane or touch to a foot sole”, and as shown in Photo 2, “I walk while feeling the edge of the platform with the tip of the white cane and checking the warning block with touch to a foot sole”. The survey subject who walks while feeling the edge of the platform with the tip of the white cane, added, “Although I don’t think this is the best way because there is a risk associated with an approaching train, I have no other choice”. As a reason for continuing to do so despite a potential risk, this person pointed out that even though he wants to walk inside the warning blocks (closer to the center of the platform) with the tactile directional bar as a guide, it is difficult to do that because of the people lining up, waiting for a train on the platform and some luggage placed in the way.
